**4TH WORLD LANDSLIDE FORUM**

**POST FORUM STUDY TOUR GUIDE BOOK:**

**LIVING WITH SLOPE MASS MOVEMENTS IN SLOVENIA AND ITS SURROUNDINGS**

**SATURDAY 3 JUNE – MONDAY 5 JUNE, 2017**

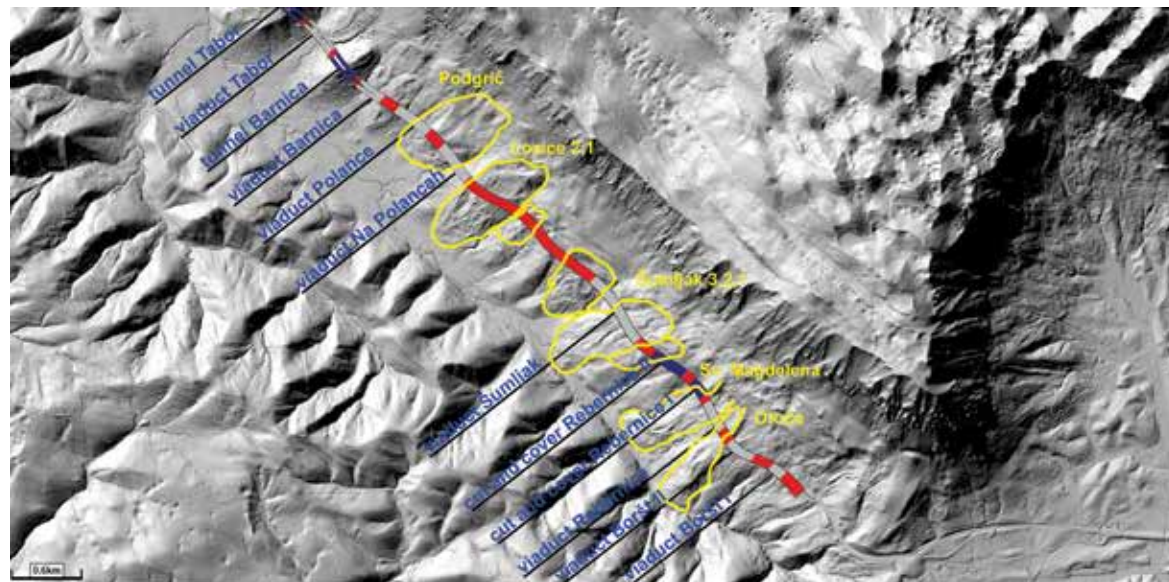
Fig. 4: Motorway H4 Razdrto-Vipava at Rebrnice with marked objects. Location of landslides (sedimentary bodies) are taken from Popit (2016).

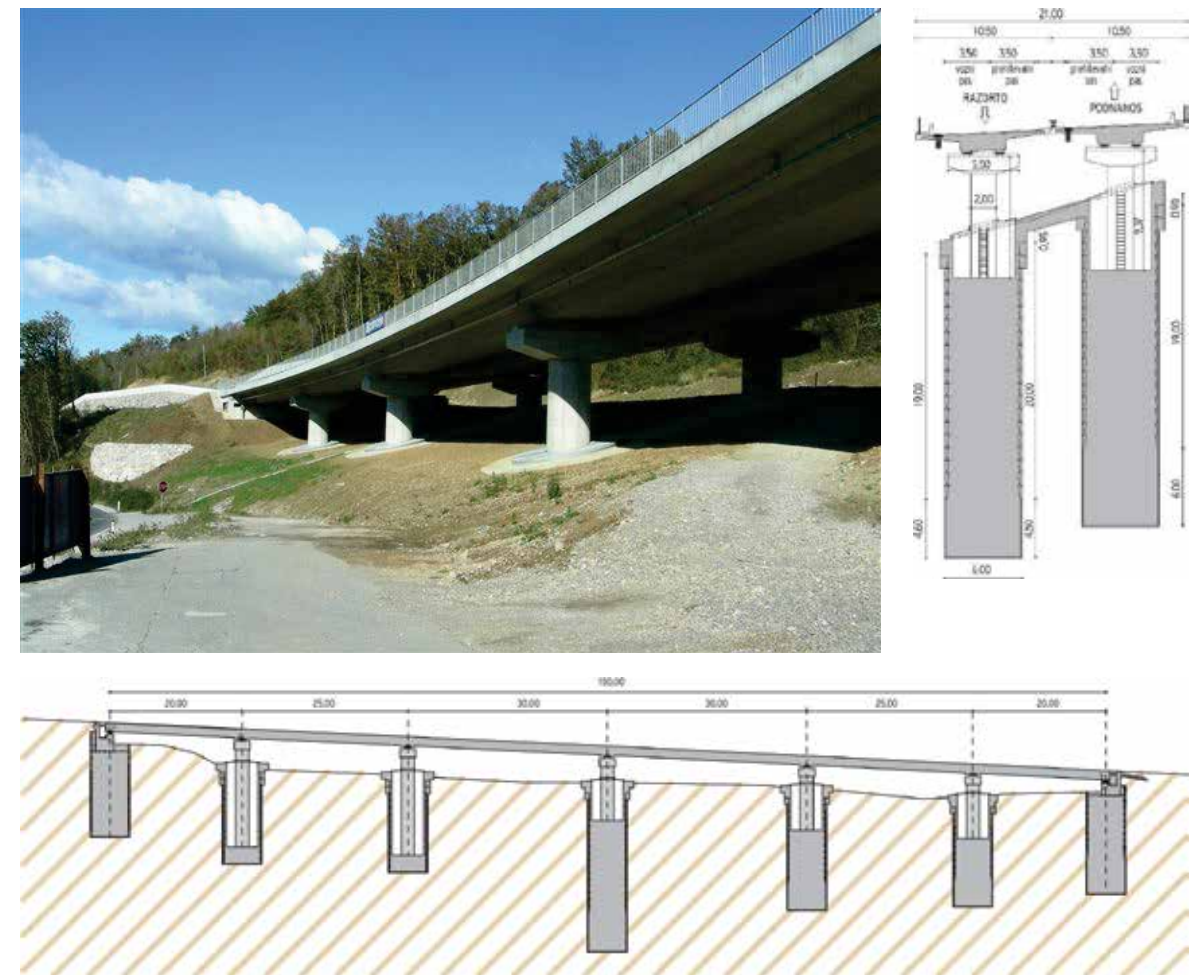
Fig. 5: Viaduct Boršt I (<http://www.fg.uni-mb.si/nanos/fotogalerija.htm>) with the cross-section trough central shaft and the longitudinal cross section. The hollow shafts enable movements of landslide without any force acting on bridge pillars.

In the case of the Boršt viaduct a foundation is made 13–22 m deep with a smaller viaduct column in a center, which enables movements of the upper less stable mass together while there are no earth pressures acting on a viaduct pillar (Fig. 5). Strong supporting structures (Fig. 6) were needed to maintain the temporary stability of slopes (Petkovšek et al., 2013). Nevertheless, many slope stability issues are still active concerns; and they indicate the need for remediation in some road sections. Recently, we have been monitoring some very extensive reactivated landslides. A thick cover of Quaternary superficial deposit (carbonate scree deposit) and breccia, tectonic deformations in the flysch, the presence of groundwater and the specific geomorphological setting represent highly significant technical challenges for the management of landslides.

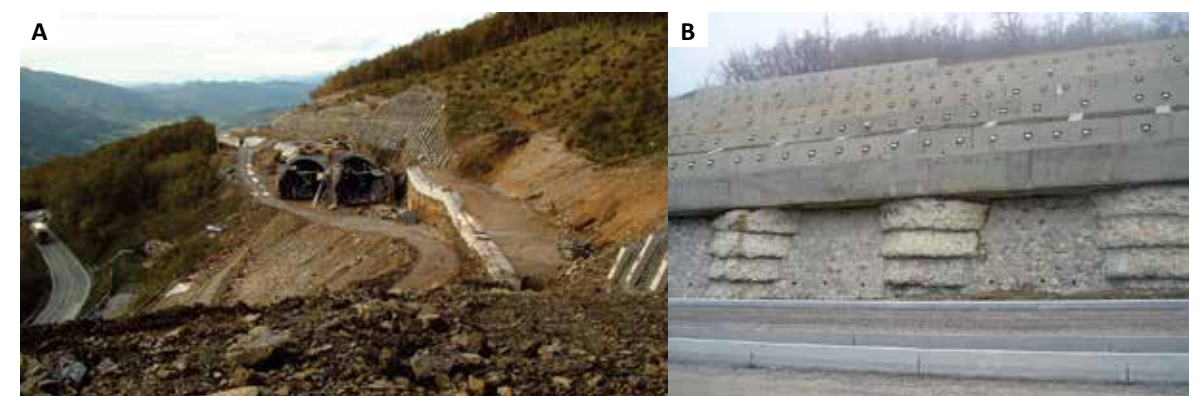
Fig. 6: A- Construction of cut and cover tunnel Rebrnice I. B- Shafts used as a retaining structure near SOR (Lozice) landslide.

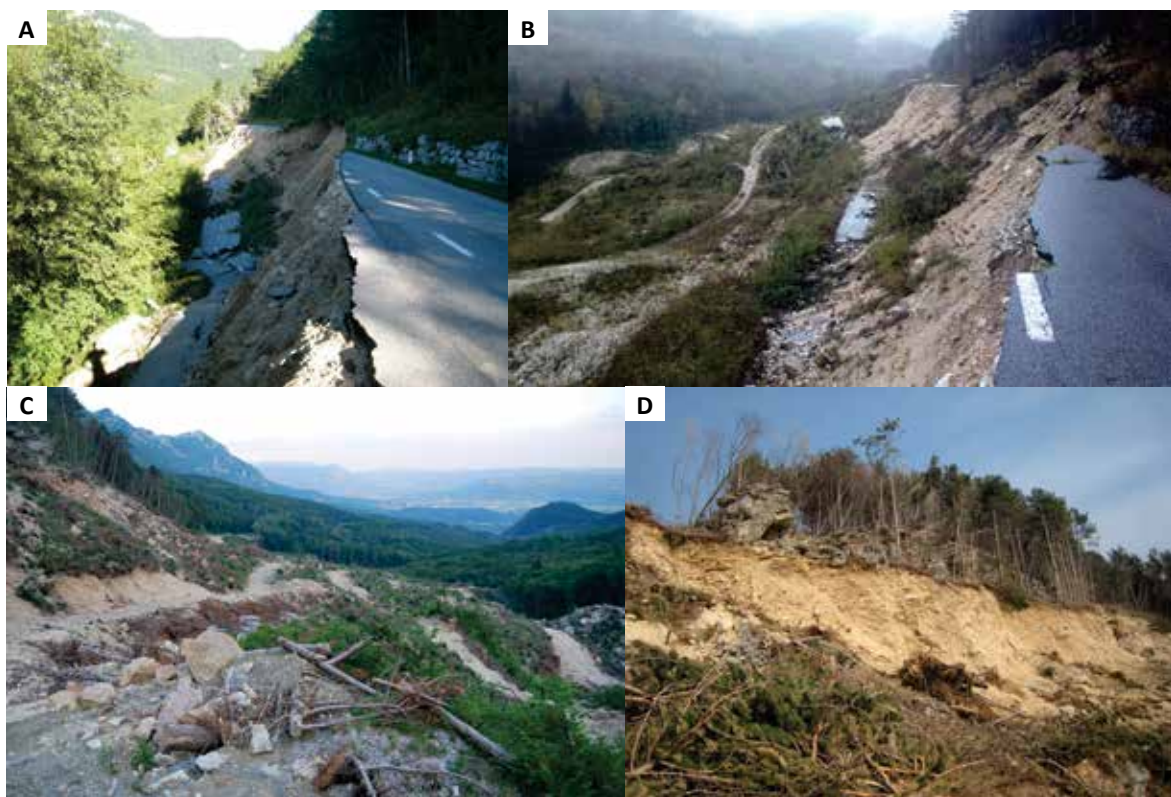
Fig. 7: Landslide Stogovce A, B- a view towards north on the destroyed road; C- The view of Stogovce landslide, view towards south; D- The main scarp. Carbonate breccia overlies carbonate scree.

The Stogovce landslide is located ca. 200 m below the carbonate overthrust front atop Eocene flysch (Petkovšek et al. 2011, Jež et al., 2011). In this area, the flysch bedrock is covered by weathered flysch and carbonate scree cover some 6–28 m thick. The scree is sometimes consolidated into carbonate breccia. Individual larger carbonate blocks some cubic meters in size are also present in the sediments (Verbovšek et al., 2017a). The landslide zone was active even before the triggering of the landslide of 2010. These developments were observed since 2000 on a local road as cracks and smaller slides, with the road in constant need of maintenance (Petkovšek et al., 2011). No monitoring of movements was applied at that time. The Stogovce landslide was triggered by an extreme precipitation event on 18 September 2010 as two small rotation slips. On September 19 about 0.5 m high scarps appeared on the road and towards the evening, the rate of displacements increased significantly, and the road moved for 5 to 8 m (Fig. 7).

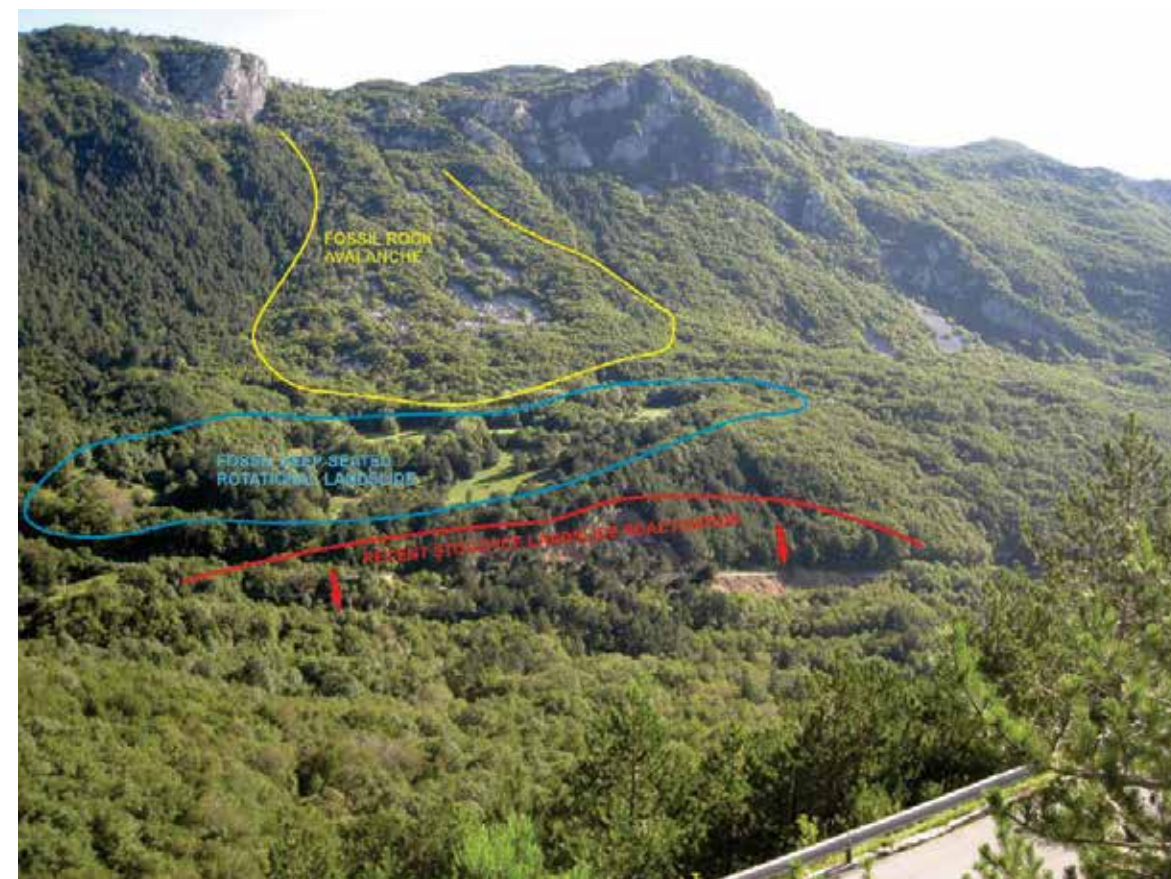
Fig. 8: Interpretation of Stogovce landslide, older fossil landslide in the upper part and more recent activation in the lower part.

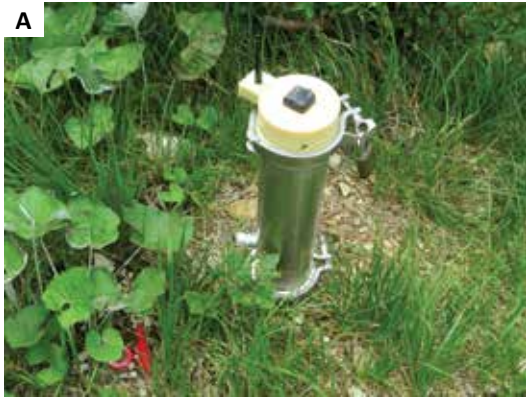
Fig. 9: A- installed GEASENSE probe; B- Locations of GEASENSE probes (Verbovšek et al., 2017a).

Monitoring of the landslide is performed using GNSS probes (Fig. 9) and inclinometers and indicates movement in the range of 1–5 cm/year, with maximum values up to 3 cm/month (Verbovšek et al., 2017a). The GNSS probes also act as an early warning system when monitored movements exceed 10 cm per day.

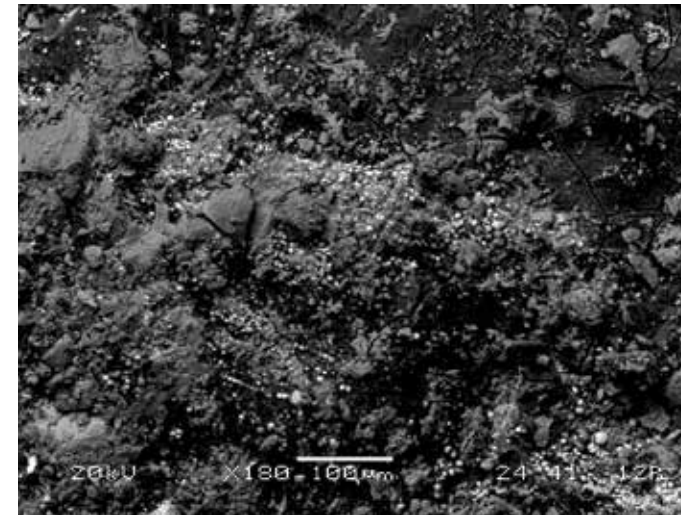
Fig. 10: Deteriorated flysch surface covered with pyrite. Micro cracks could also be visible (Petkovšek, 2006).

The Slano blato landslide is located above the village of Lokavec in the Vipava River Valley. This landslide differs from other landslides in the Vipava Valley by a mud-dominated composition of the transported material and the occurrence of salt efflorescences (predominantly sodium sulphate of the thenardite-mirabilite system) on the landslide surface (Martín-Pérez et al., 2016), hence the name Slano Blato, meaning 'salty mud'. The salt efflorescences are a result of dissolution of sulfates and sulfides which were found together with organic content on discontinuous inside the flysch rock (Fig. 10) (Petkovšek, 2006).

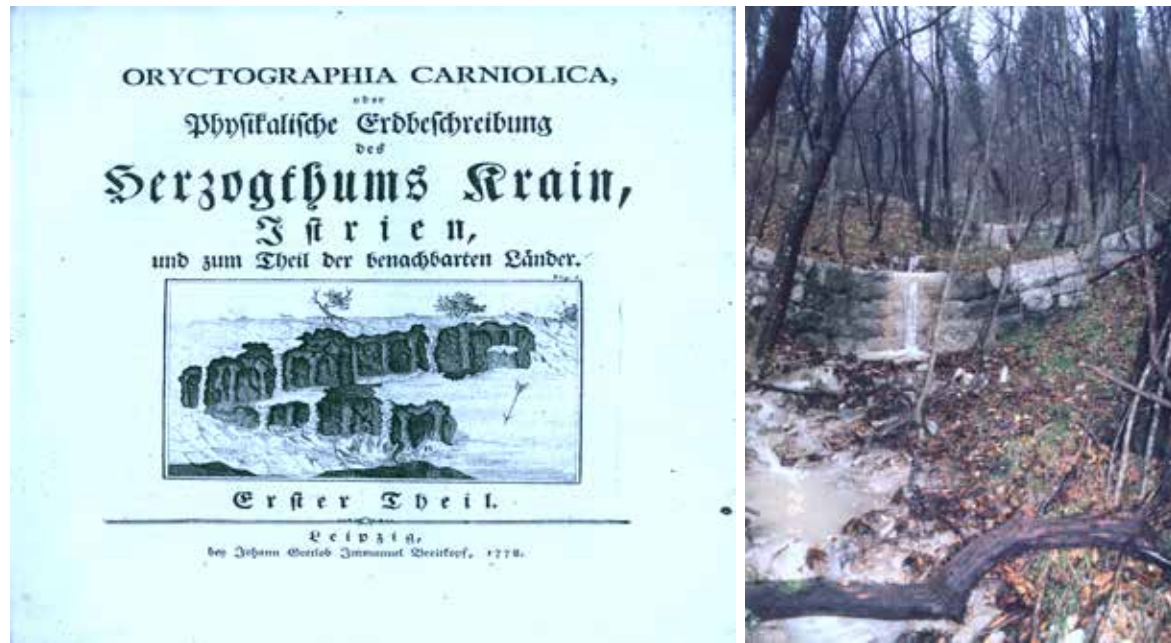
Fig. 11: The first source of the landslide in 1789 (Hacquet, 1789) and the old check dams from the beginning of the 20th century (Benko, 2011).

The main scarp is located near the carbonate overthrust atop Eocene flysch. In the more remote part of the landslide is a structural depression that renders the area relatively unstable, owing to the high underground water table it sustains (Placer et al., 2008). Historical sources reported events in 1786 and 1885 (Fig. 11), when landslides flooded the villages and the main road at the bottom of the valley. At the end of the 19th century, the first retaining measures were taken: small check dams (Fig. 12) were erected in order to retain the mud and reduce the slope angle. The stream bed was widened, and a construction ban in the influence area was put into effect (Logar et al., 2005). These structural measures had badly deteriorated or been completely neglected, and the landslide was retriggered some 100 years later, on 17–19 November 2000 during a period of heavy and long lasting rain. Since then, many researchers have investigated and monitored this landslide, largely in order to define displacement rates and the landslide's particular characteristics that later formed the basis of the mitigation and remediation measures (Majes et al., 2002; Ribičič and Kočevar, 2002; Logar et al., 2005; Placer et al., 2008; Fifer Bizjak and Zupančič, 2009; Mikoš et al., 2009; Maček et al., 2016; Martín-Pérez et al., 2016). The landslide started as a rotational slide at the altitude of ca. 570 m. Within a few days, it had grown to a length of 500 m, and to 60–250 m wide and 10 m deep (Fig. 13). The material moved consisted of clayish gravel in the upper area and weathered flysch in the lower area (Fig. 14) (Ribičič and Kočevar, 2002). Due to continuous rainfall at the time, together with the uneven landslide surface, lakes formed in the landslide area. The water wet the sliding mass and transformed it into a mudflow, with a downward maximum velocity of 60–100 m/day and coming to a halt at the altitude of 460 m (at 'Mud Lake'). Earthflow events repeated several times in the years that followed (2001–2004), and occasionally the material transformed into minor yet very rapid to extremely rapid mudflows. At the same time, the retrogressive rotational slide occurred above the main scarp, feeding the landslide with new unstable masses. The landslide is currently 1.4 km in length and boasts a volume of more than 1 million m<sup>3</sup>.

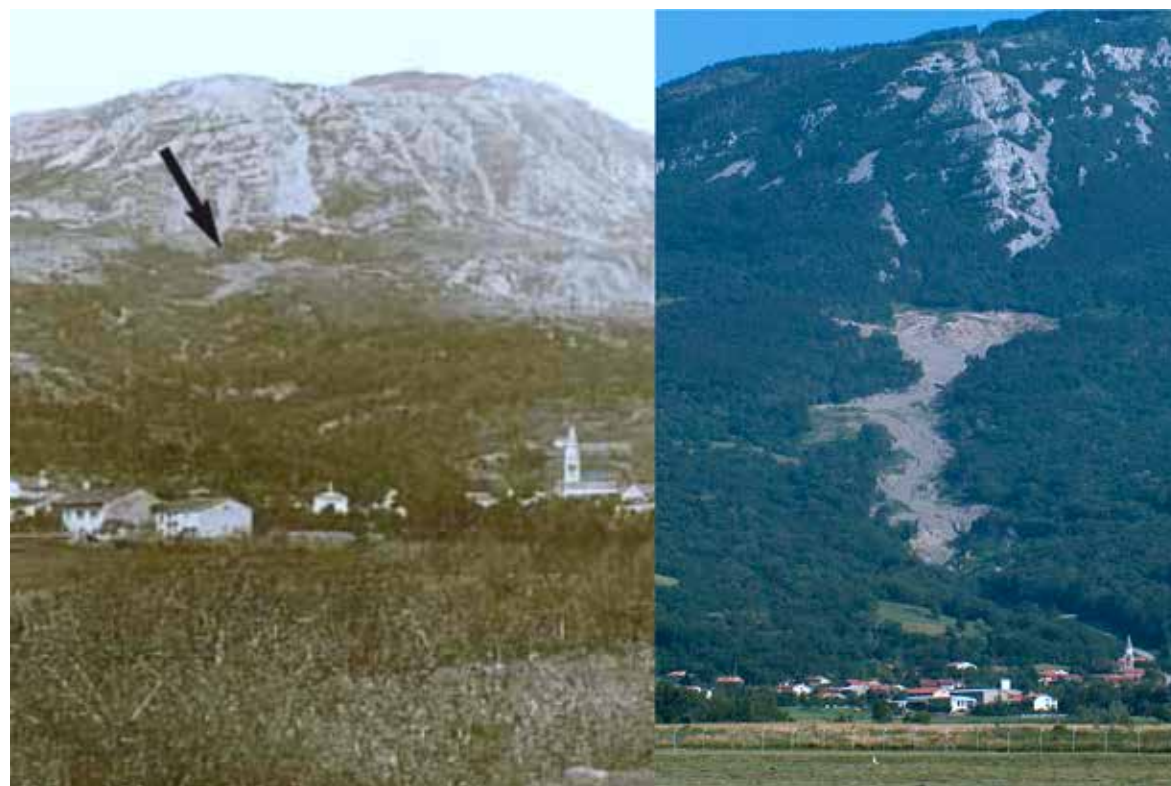
Fig. 12: About a 125 years old photography of Slano blato landslide (Dušan Hmeljak) and Slano blato in 2011 (Benko, 2011).

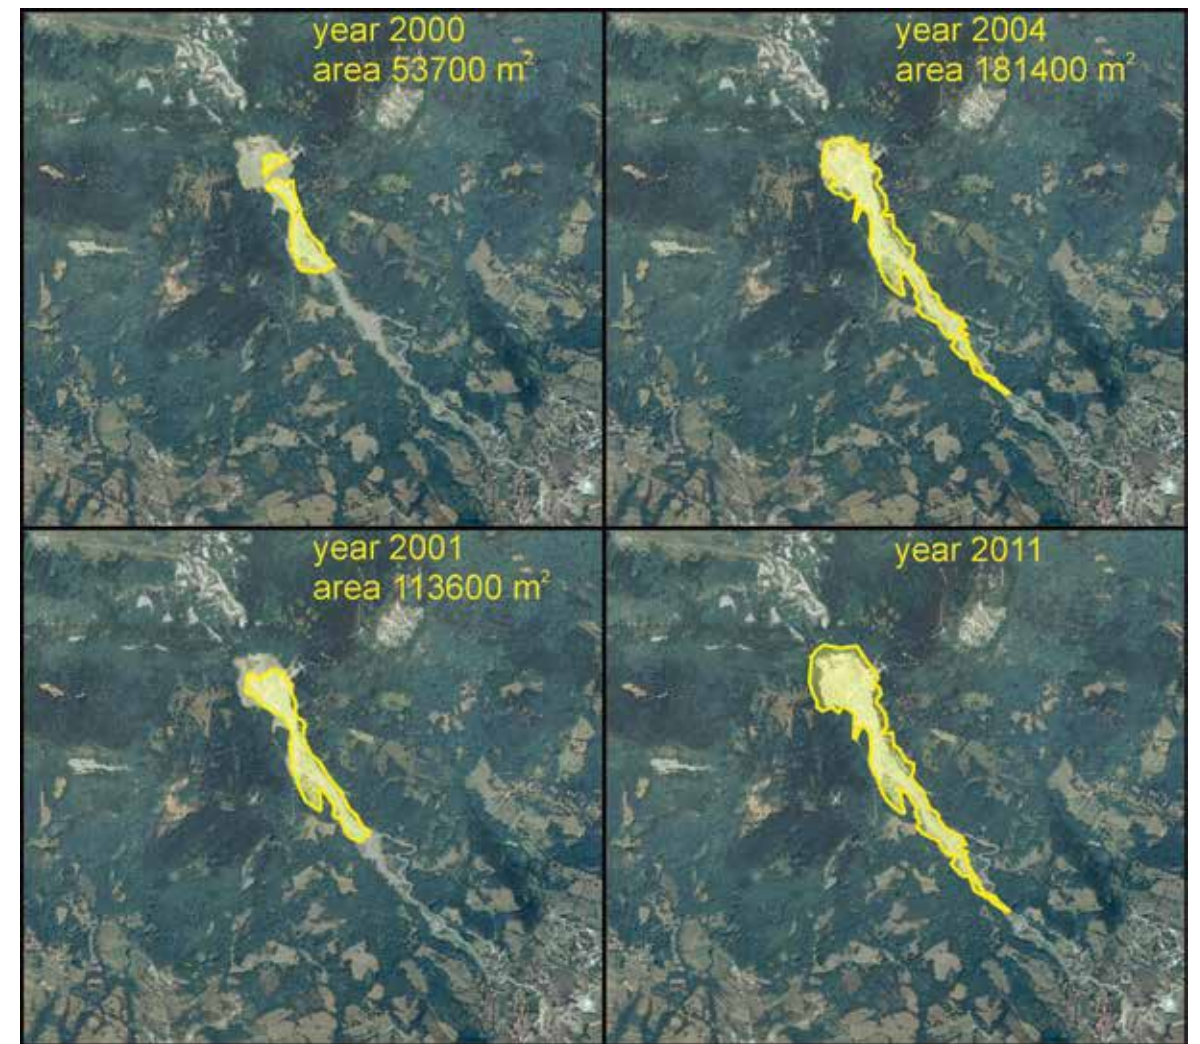
Fig. 13: Progressive widening of the Slano blato landslide (Petkovšek et al., 2013).

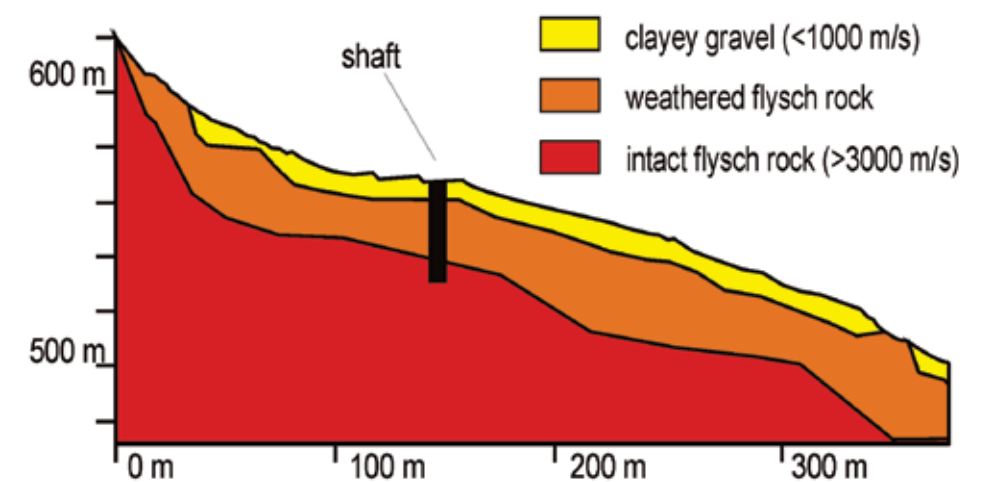
Fig. 14: Simplified geoseismic refraction profile with the shaft position (Petkovšek et al., 2013).

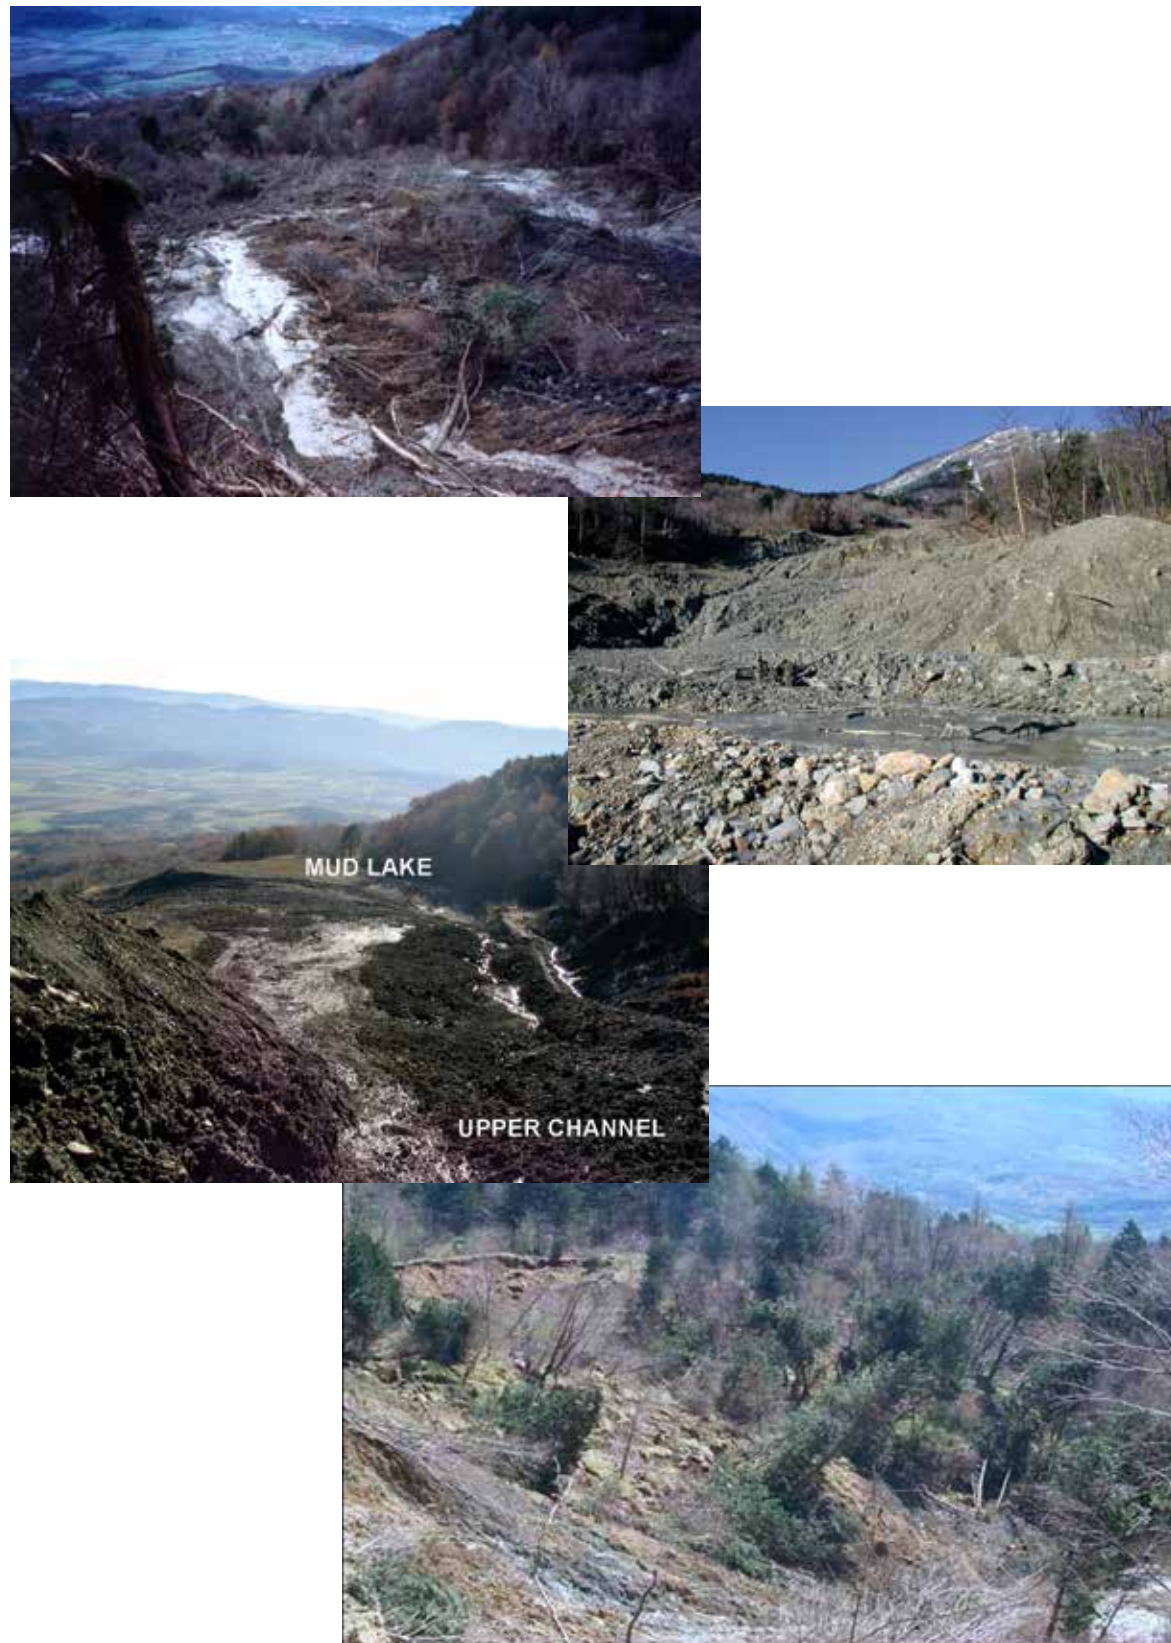
Fig. 15: Slano blato landslide in 2000 (upper part) and 2003 (lower part) (Petkovšek et al., 2010).

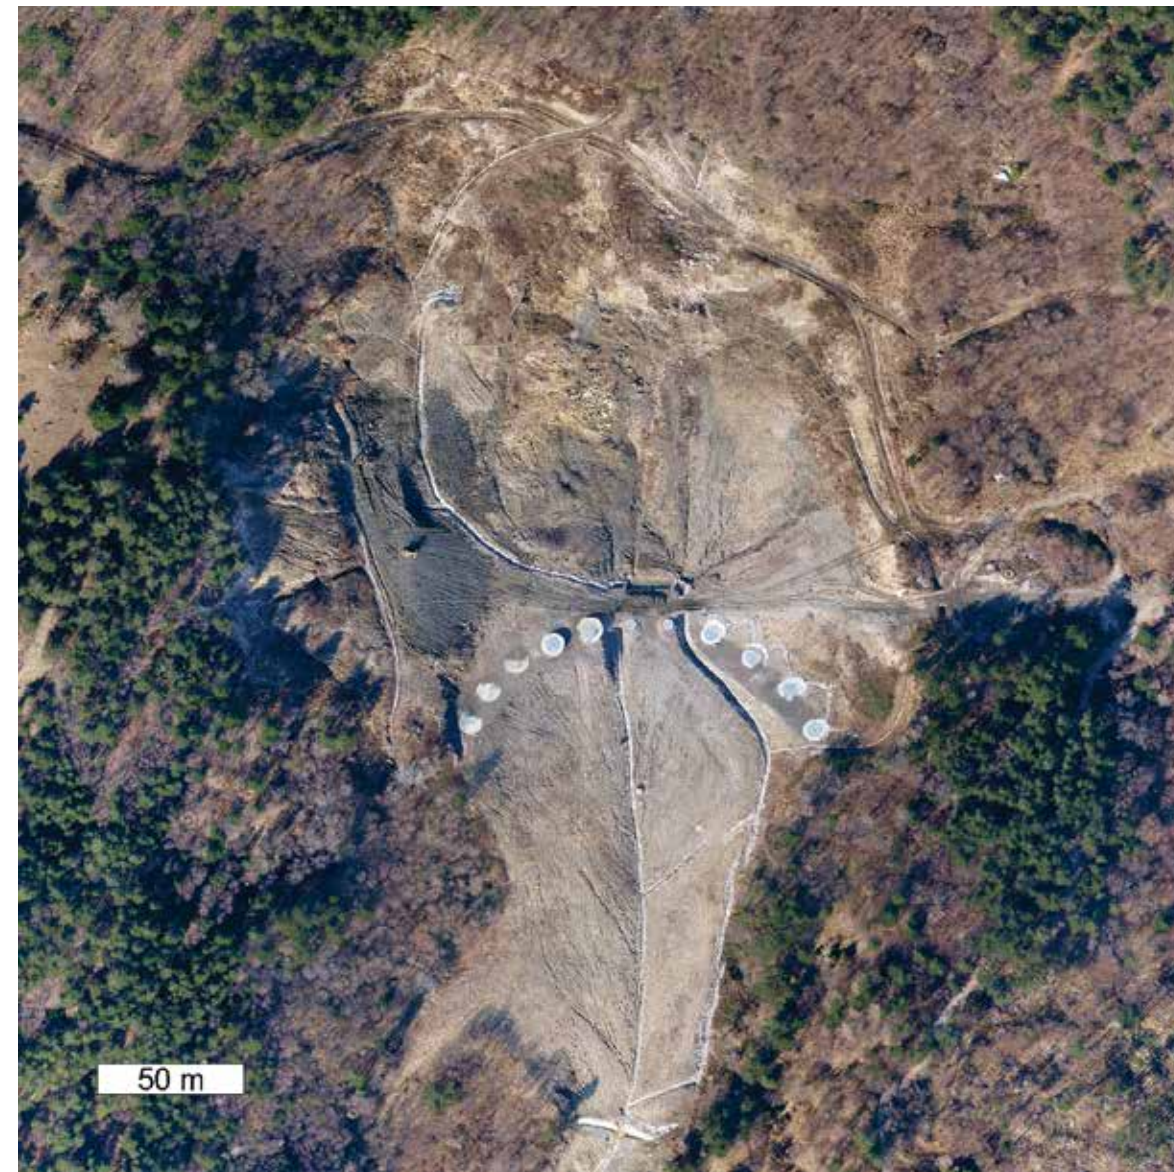
Fig. 16: Aerial view of the upper part of the Slano blato landslide with shafts and a small concrete dam (Pulko et al., 2014).

In order to protect the village from potential landslides, a small rockfill dam was constructed in 2002, with a retention volume of 5,000 m<sup>3</sup> and some 200,000 m<sup>3</sup> of material were removed from the landslide body. Between 2004 and 2007, several reinforced concrete shafts were constructed deep at the upper part of the landslide designed to stop its progressive widening. These shafts measure 8 m in diameter and run 24 m in depth, and serve both as a dewatering measure and as a retaining structure (Fig. 16; Fig. 17) (Pulko et al., 2014). In addition to the shafts, a 2 m high concrete dam was constructed to reduce the slope inclination below the dowels, the surface underwent a reshaping procedure, and a surface dewatering system was constructed (Fig. 18). Another 13 m high concrete dam is in construction to reduce erosion processes at 'Slap' (waterfall) location and prevent destabilization of the landslide body in the lower part of the Slano blato landslide. As a result of these retaining measures, the landslide is active only at the main scarp.

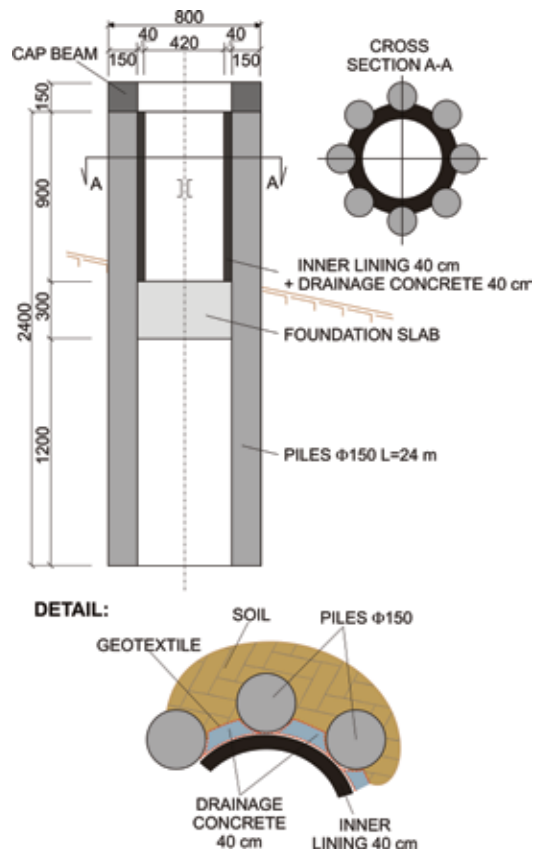
Fig. 17: Spatial scheme with vertical and horizontal cross-section of the modified design (left) (Pulko et al., 2014) and the placing of drainage concrete (top right) and the view on construction site in 2005 (lower right) (photo Geoinvest).

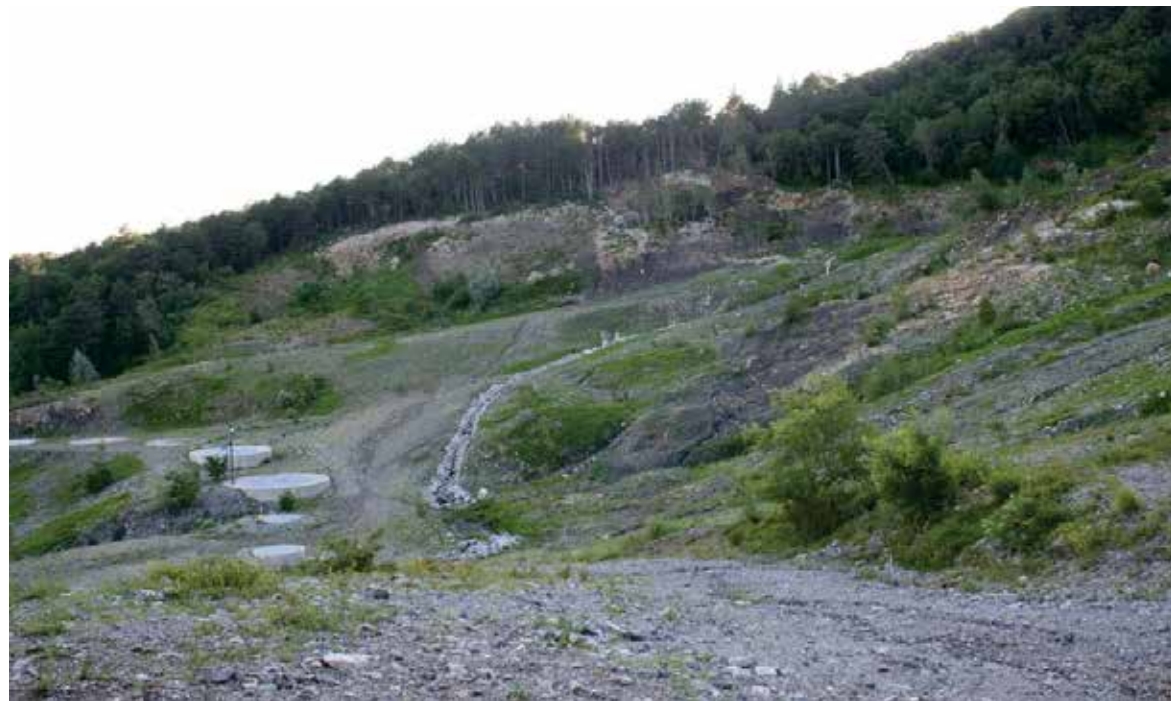
Fig. 18: Upper part of the Slano blato landslide above shafts in 2011.

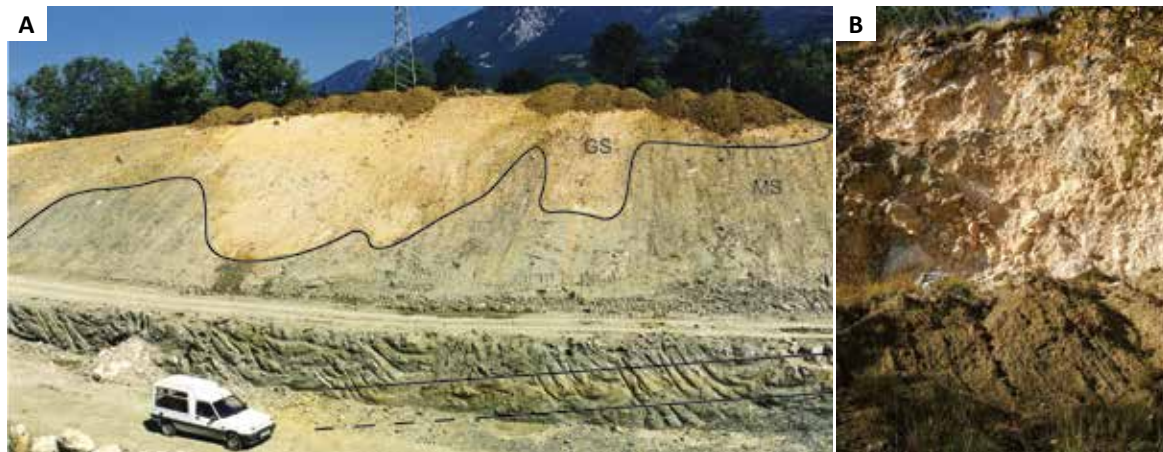
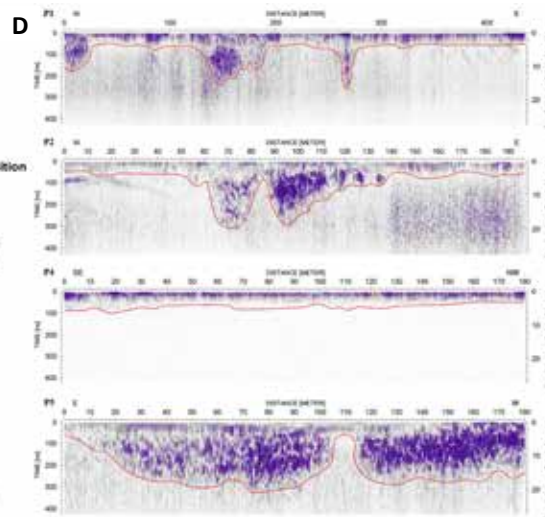
Fig. 20: A- Location of GPR1 profile. Cross section of the Selo landslide on the Vipava-Nova Gorica motorway construction site in 1999. GS indicates that clast-supported unit consists predominantly of limestone gravel with a subordinate amount of limestone cobbles and blocks; MS indicates that a mud-supported unit composed of pebbles, cobbles and several cubic metre blocks of limestone and sandstone, embedded in a muddy matrix. PS: palaeosol, FL: flysch composed of an alternation of siltstone, sandstone and marls. B- GS unit overlying the flysch in the Ravenščak ravine. C- Locations of the sediment thickness measurements in the ravines, GPR profiles, cross-sections, boreholes and extent of the Selo landslide. D- GPR profiles CP, P1, P2, P4 and P5 with boundary marked between the GS and MS units.

The Selo Landslide is a large landslide from Pleistocene composed predominantly of coarse carbonate material and characterized by its exceptional size and considerable runout length (Fig. 19) (Verbošek et al., 2017b, Košir and Popit, 2017). Landslide extent area of the carbonate debris is 4.5 km<sup>2</sup>, covering an area of more than 10 km<sup>2</sup>, with an estimated volume of about 190 × 10<sup>6</sup> m<sup>3</sup>. The estimated material balance, sediment volume and geometry indicate that the main landslide deposit most likely corresponds to a large-scale collapse of the upper carbonate slope (escarpment) developed from rock avalanche. Parameters describing the geometric relationships of the Selo landslide (an apparent friction coefficient, defined as H/L ratio; Fahrböschung) and its estimated volume correlate with data for landslides of comparable size (e.g. Legros, 2002), including some examples of typical rock slides (avalanches). Radiocarbon dating of wood debris entrained by the Selo landslide and excavated from the underlying paleosol and basal layers of landslide deposits yielded radiocarbon-dead values, clearly indicating the pre-Holocene age of the landslide (Popit and Košir, 2003). To determine the volume and geometry of the landslide and its potential source area, we integrated geological mapping, ground penetrating radar (GPR) and GIS techniques (Fig. 20).

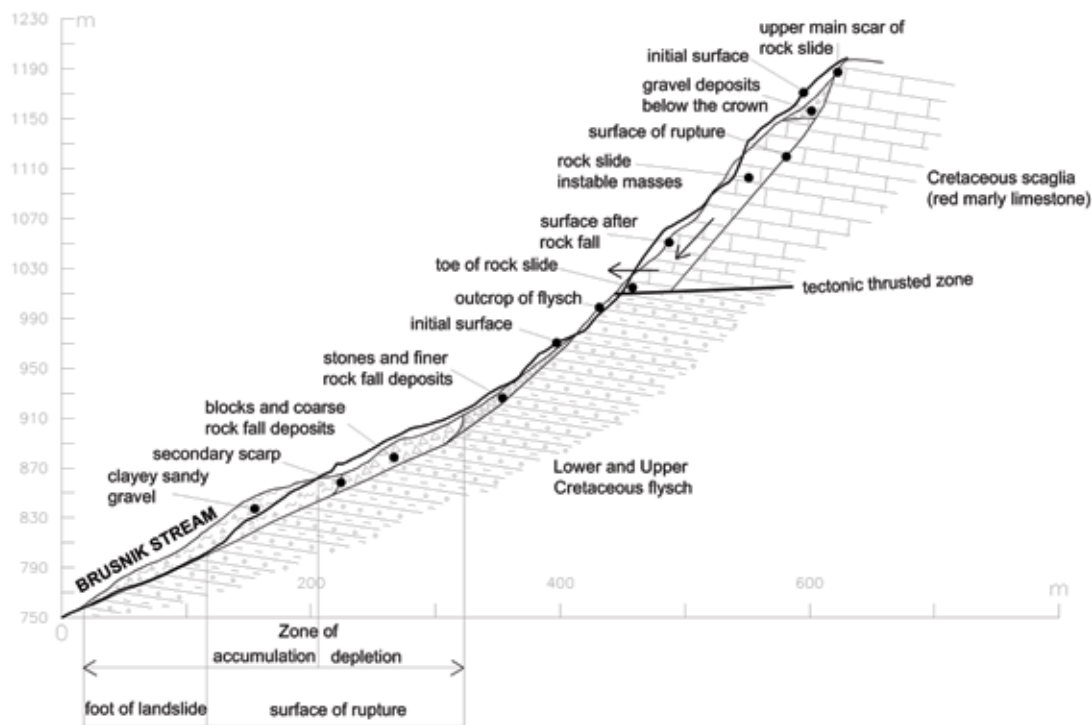
Fig. 23: The geological longitudinal profile of the Strug landslide with the rockslide and the soil landslide features (Mikoš et al., 2006a).

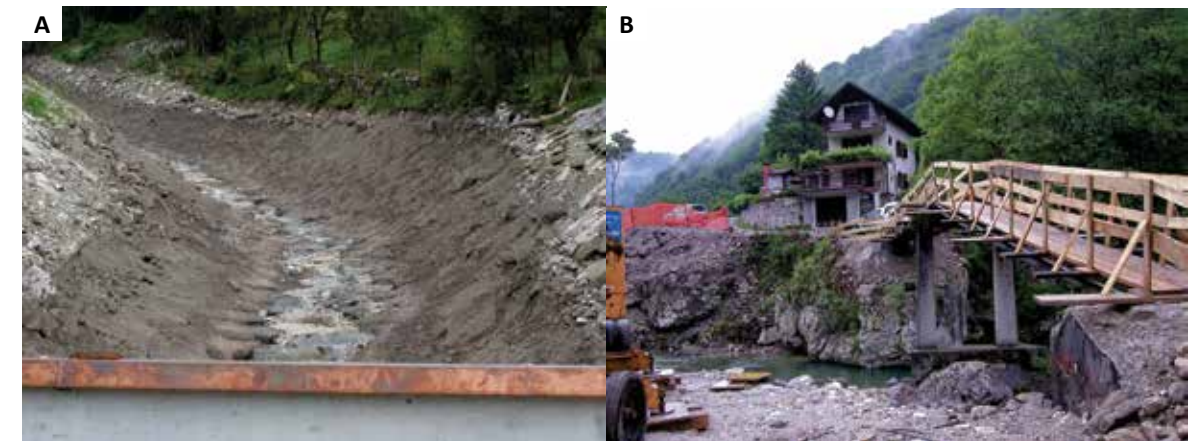
Fig. 25: Mitigation measures. A- Enlarged parabolic channel cross-section of largely constant longitudinal slope and no sharp curves; B- Implementation of a new bridge with nearly twice the span of the old bridge to connect the two parts of the village.

Observed data (velocity, debris-flow head height and estimated volumes of single surges) for debris flows flowing from the Strug source area, together with the estimated rock fall debris available for debris flow generation, were used to develop a numerical model for potential debris flows for a maximum estimated debris flow of 20,000 m<sup>3</sup>. The Brusnik channel was much enlarged and reformed into a parabolic cross-section with a constant longitudinal slope, and with mild curves (no sharp bends) (Fig. 25A). Furthermore, a new bridge with nearly twice the span of the old bridge was

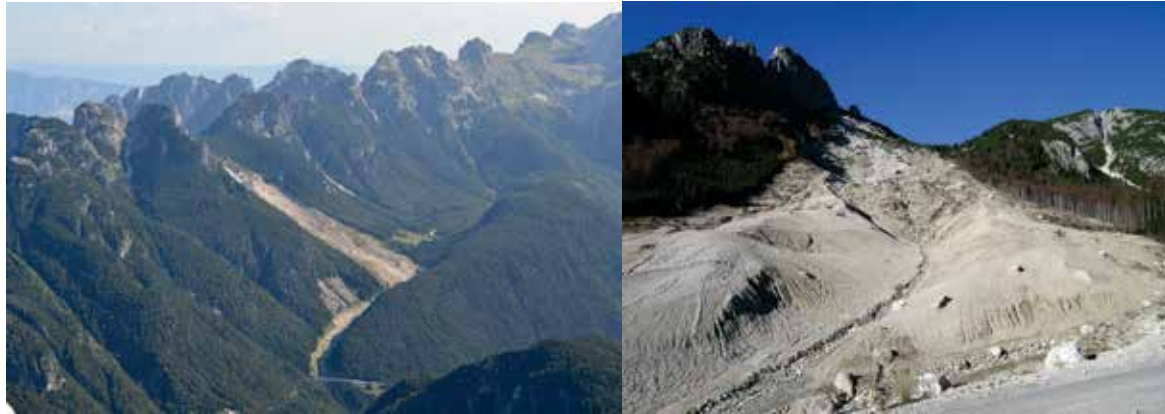
Fig. 26: Stože landslide source area.

The Stože landslide (Fig. 26A) which hit the village of Log pod Mangartom (Fig. 27) in western Slovenia minutes after midnight on 17 November 2000, was the largest single natural catastrophe to be recorded in the territory of Slovenia in the second half of the 20th century. The landslide event claimed seven lives and was the source of many discussions related to the possible cause(s) (local earthquake, heavy rainfall, and other influences) and immediate triggering factors, as well as the responsibility for its tragic consequences. The Stože landslide was triggered in the Koritnica River catchment, which covers an area of 87 km<sup>2</sup>. Permeable karst formations, glacial deposits, and alluvial formations are prevalent in this mountainous catchment; the only formation of low permeability in the region is located in the sub-catchment where the Stože landslide occurred (Mikoš et al., 2004).

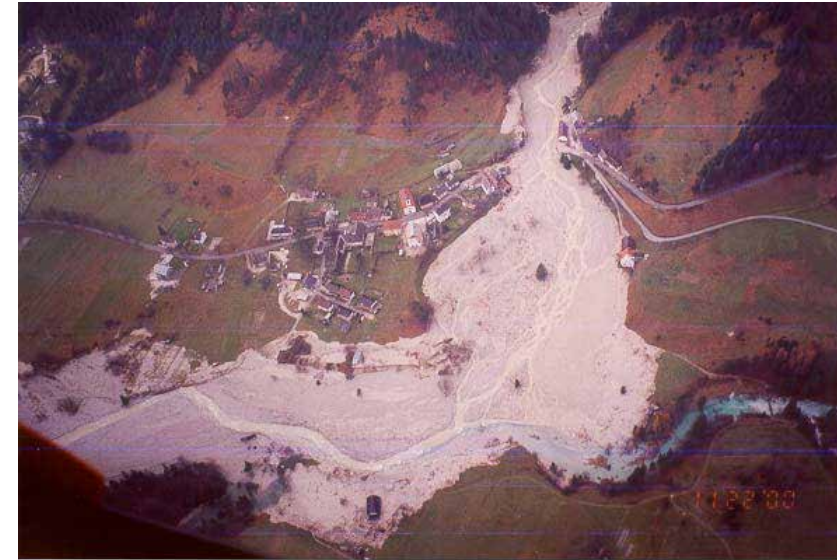
Fig. 27: Aero view of the debris flow deposits in the settlement Log pod Mangartom after the devastating debris flow in November 2000 which claimed seven lives.

In two separate events, on 15 and 17 November 2000, near the Mangart Mountain (2,679 m a.s.l.), NW Slovenia, two translational landslides composed of morainic material (glacial till) filled with silt fraction (Fig. 27), with a total volume of more than 1.5 million m<sup>3</sup> occurred on the Stože slope. The first landslide was associated with a dry debris flow, and the second landslide with a wet debris flow. The rain-gauging station in the village of Log pod Mangartom recorded 1638.4 mm of rainfall (more than 60% of the average annual precipitation) in the 48 days, leading up to the events (rainfall intensity of 1.42 mm/h in 1152 h). The Stože landslide (two debris flow) was triggered by high artesian pressures built up in the slope after prolonged rainfall. The devastating dry and wet debris flows formed as the result of the Stože landslide masses undergoing significant infiltration of rainfall and surface runoff into the landslide masses and their subsequent liquefaction (Mikoš et al., 2004).

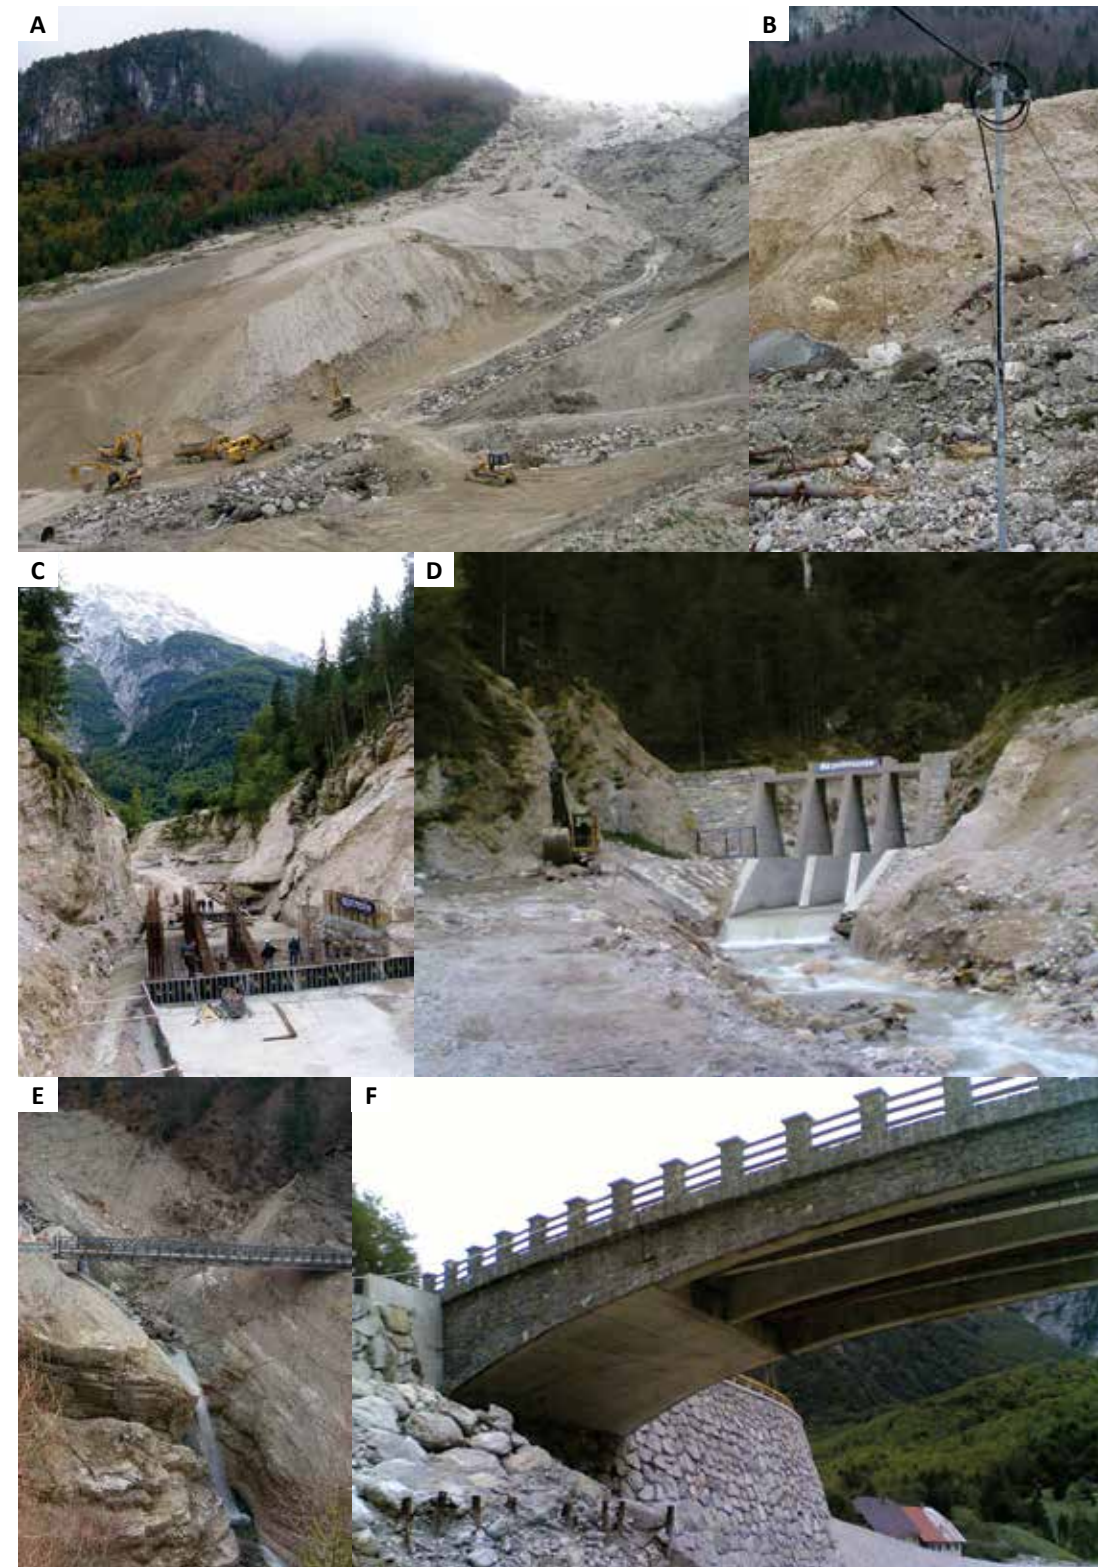
Fig. 30: Extensive remediation works: A- disposal of debris flow material; B- Early warning system; C and D- debris flow breaker during and after construction; E- two damaged roads were replaced by a temporary construction (prefabricated steel bridge); F- the new bridge.

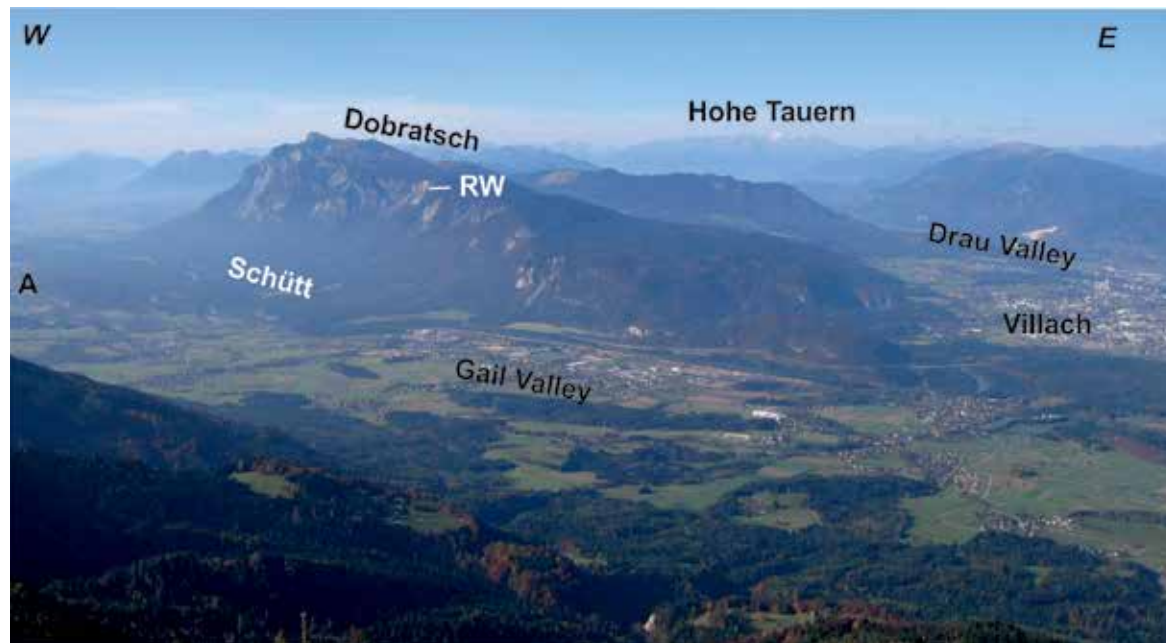
Fig. 35: The Dobratsch massif and its surrounding viewed from SE and the E-W running Gail Valley in the south. Multiple scarps on its southern flank are evident (e.g. Rote Wand- RW). The woods at the toe and its immediate southern foreland, (the so called Schütt) cover the prehistoric and historic rock avalanche deposits. In addition, the location of the town of Villach at the confluence of the rivers Gail and Drau, and that of the village of Arnoldstein (A) are indicated. Towards North, the still glaciated peaks with altitudes of up to 3,360 m a.s.l. of the Hohe Tauern mountain range can be seen.

The Dobratsch massif (Fig. 35, Fig. 36), also known as the Villacher Alpe, with its highest peak at 2,166 m a.s.l., is located west of the city of Villach on the northern flank of the Gail Valley (valley floor at 550 m a.s.l.), which follows the Periadriatic Fault. It represents the eastern most part of the Gailtal Alps, a mountain chain on the southern flank of the Eastern Alps south of the Hohen Tauern mountain chain. The Dobratsch massif is a popular recreation area with an excellent panoramic view which is easily reached from Villach via the Villacher Alpenstraße mountain road. The Dobratsch and its southern foreland, the so called "Schütt", are a protected landscape of the "Naturpark (nature park) Dobratsch" and include two NATURA 2000 areas according to the European Union.

The Dobratsch belongs tectonically to the Drauzug-Gurktal nappe system of the Austroalpine Superunit (Schmid et al., 2004). Its southern limit is given by the E-W trending Periadriatic Fault, a major strike-slip fault which runs in the glacially overdeepened Gail Valley (Fig. 35, Fig. 36, Fig. 37) and delimitates the Austroalpine from the South Alpine Superunit. Towards the basin of Villach in the east, the massif shows a stair-cased normal faulting along N-S trending faults (Colins & Nachtmann, 1978). A thrust plane separates a lower and an upper tectonic unit (Fig. 38).
