**4TH WORLD LANDSLIDE FORUM**

**POST FORUM STUDY TOUR GUIDE BOOK:**

**LIVING WITH SLOPE MASS MOVEMENTS IN SLOVENIA AND ITS SURROUNDINGS**

**SATURDAY 3 JUNE – MONDAY 5 JUNE, 2017**

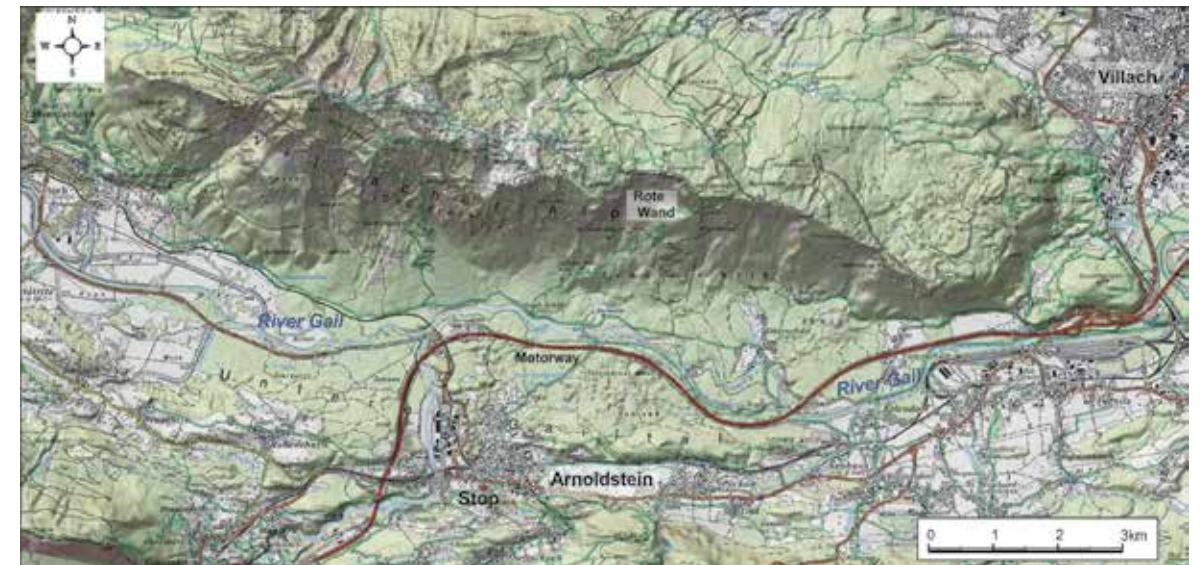
Fig. 36: A topographic map (base map: BEV) with shaded relief (provided by Land Kärnten data.gv.at) of the Dobratsch Site with the location of the Stop at Arnoldstein.

The Dobratsch massif (Fig. 35, Fig. 36), also known as the Villacher Alpe, with its highest peak at 2,166 m a.s.l., is located west of the city of Villach on the northern flank of the Gail Valley (valley floor at 550 m a.s.l.), which follows the Periadriatic Fault. It represents the eastern most part of the Gailtal Alps, a mountain chain on the southern flank of the Eastern Alps south of the Hohen Tauern mountain chain. The Dobratsch massif is a popular recreation area with an excellent panoramic view which is easily reached from Villach via the Villacher Alpenstraße mountain road. The Dobratsch and its southern foreland, the so called "Schütt", are a protected landscape of the "Naturpark (nature park) Dobratsch" and include two NATURA 2000 areas according to the European Union.

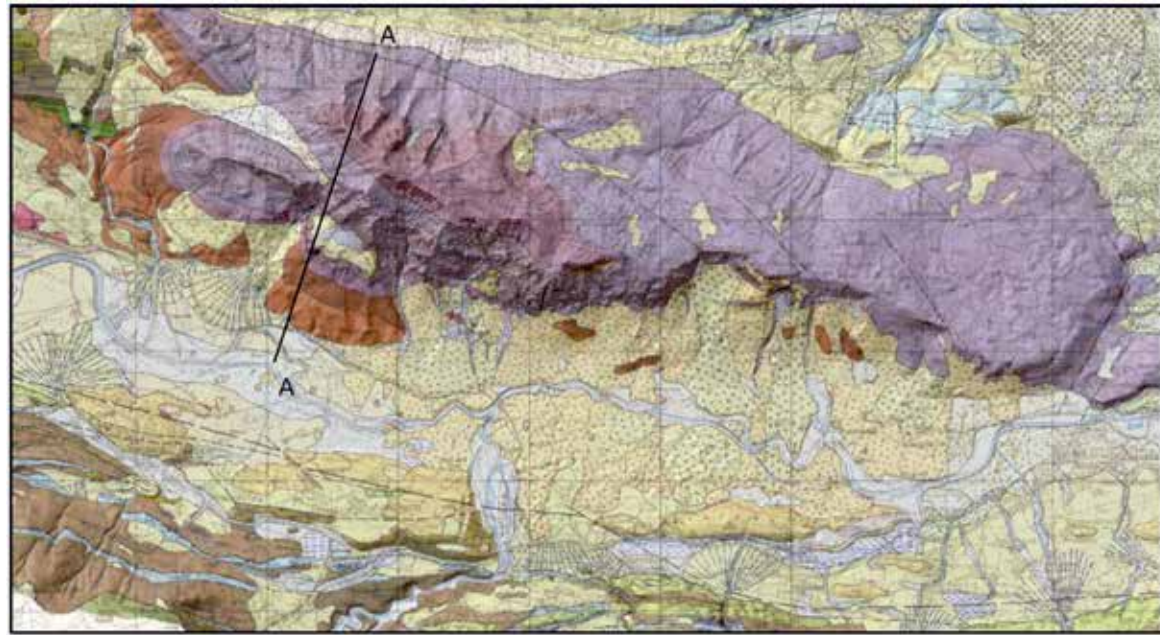
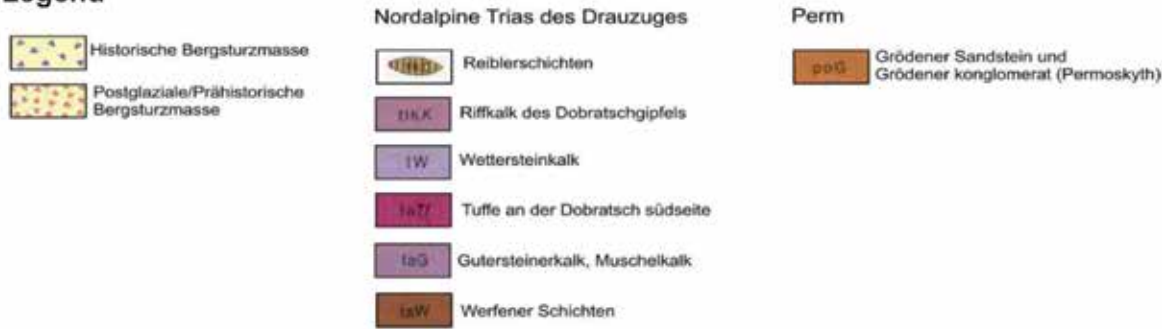
Fig. 37: Geological map of the Dobratsch massif (Villach Alps; Anderle, 1977).

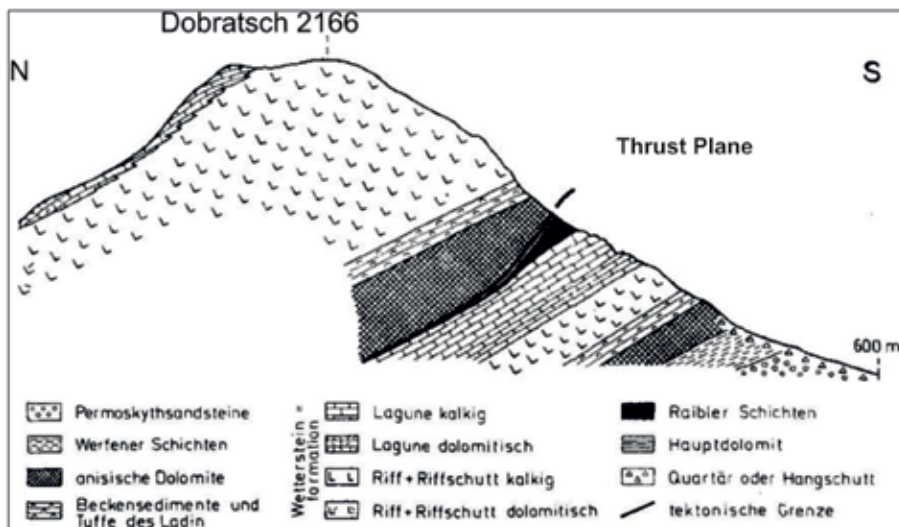
Fig. 38: A simplified N-S geological cross section through the mountain of Dobratsch, A-A (for the location of the cross section see Fig. 37). A thrust plane (reverse fault) separates two tectonic units (after Colins and Nachtmann, 1978).

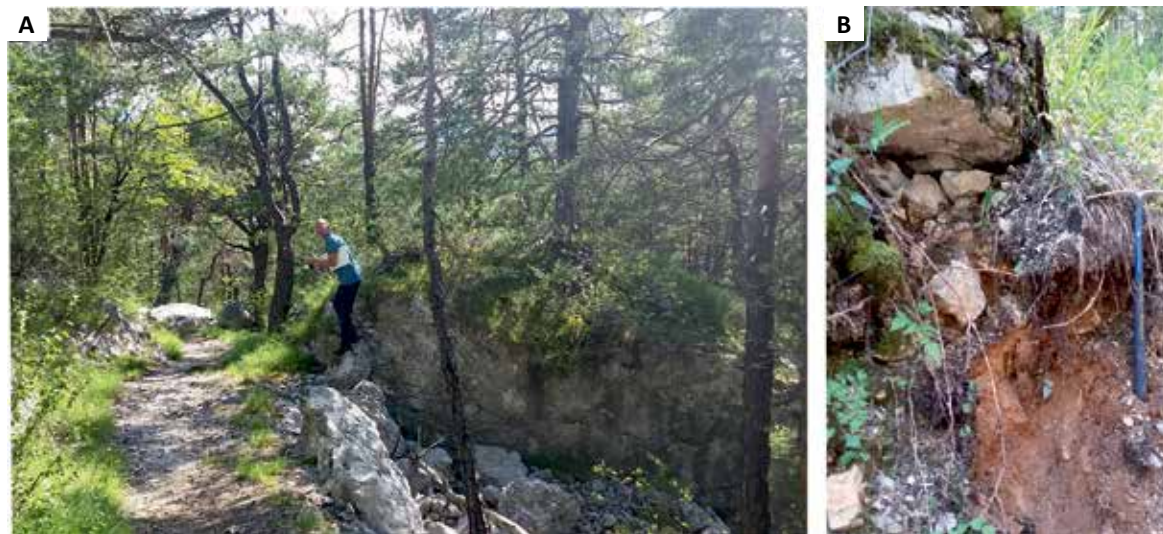
Fig. 40: A- Deposit of the pre-historic rock avalanche event in the area of the “Alte Schütt” with typical vegetation cover. B- Soil formation on top of the pre-historic deposit.

Weathered scarps, with yellow-grey, grey to reddish-grey colors mark the detachment areas of the pre-historic events predominantly on the western part of the southern flank of Dobratsch (Till, 1907). The corresponding deposits in the area of the so-called "Alte Schütt" cover an area of 16 km<sup>2</sup> with an estimated volume of 800- 900 x 10<sup>6</sup> m<sup>3</sup> (Brandt, 1981). Weathered boulders and megaboulders (> 100 m<sup>3</sup>) with rounded edges and karren (karst features) on its surface, which forms hills of up to 80 m in height (Krainer, 2013) and evident soil formation are characteristic for these older deposits (Fig. 40). The type of vegetation depends on the degree of soil development, but it mainly comprises mixed forests of Pine, Scots Pine, Spruce, and Beech. The age of these events is still a matter of discussion. However, the old view by Abele (1974), that the hummocky terrain consisting of cone-shaped so-called Toma hills proof rock avalanches falling down on a down-wasting glacier (dead ice) during ice-decay at the end of the LGM has been refuted like in so many cases in the Eastern Alps (cf. Prager et al., 2008). Drillings for the motorway A2, which runs through the area, did not show the rock avalanche deposits but alluvial deposits indicating an event at least after the glacially over-deepened Gail valley was already infilled by deltaic and fluvial sediments in the Lateglacial. However, Till (1907) also supposes an earth-quake triggering for the pre-historic events.

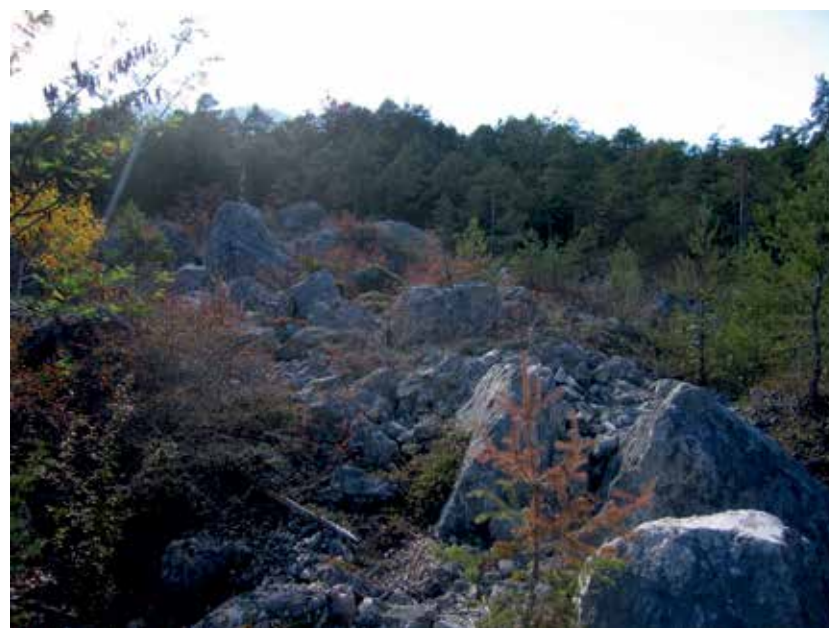
Fig. 41: Area of the “Junge Schütt” made up of the deposits from the year 1348, rock avalanche deposits with sparse vegetation.

The deposits from the year 1348 cover an area of the pre-historic event with an overlay with a thickness of 20- 30 m that (Till, 1907; Brandt, 1981). Thus, the deposition of historic rock-avalanche occurred in an unoccupied landscape which explains no immediate fatalities due to the event. The depositional area is called the “Schütt” or also “Steinmeer” (German for “sea of stones”) and shows no soil or only initial soil formation. Consequently, they are only sparsely vegetated with small pines and other plants of an early vegetational succession (Fig. 41). The surface consists predominantly of boulder and mega-boulders that are less weathered i.e. have sharp edges and show only limited signs of corrosion. Occasional outcrops show a layer of angular boulders and megaboulders (“carapace facies”; according to Dunning, 2004) which rest on finer, matrix-supported clastic material (Body Facies; Dunning, 2004).

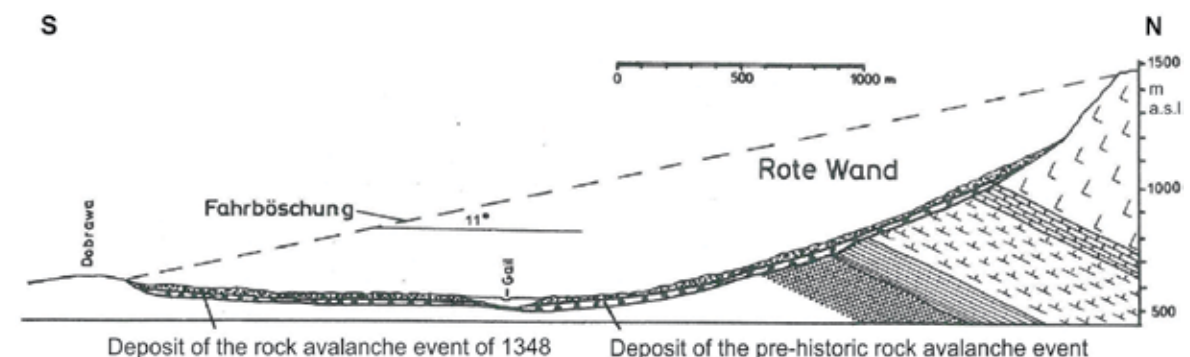
Fig. 42: Cross-section from the scarp to the deposits of the historic Rote Wand rock avalanche event (location indicated in Fig. 39).

According to the reconstruction by Brandt (1981), the mechanical differences between “hard” carbonatic rocks on top and “weak” silt to sandstones at the base enabled, together with partly karstified faults and joints, the development of cracks and, eventually, a sliding plane. Finally, the detached and fragmented rock mass behaved like a flow typical for a rock avalanche which reached its long run-out due to the mechanisms of dynamic fragmentation (McSaveney and Davies, 2006; Davies and McSaveney, 2009). This can be best studied for the “Rote Wand” event (Fig. 42) which has the biggest volume  $100 \times 10^6 \text{ m}^3$  and the lowest Fahrböschung (travel angle) of  $11^\circ$  of all historic rock avalanches (Brandt, 1981). The most pronounced fracture system is evident at the steep cliff of the “Rote Wand” (German for “Red Wall”; Brandt, 1981), which has a height of appr. 350 m. This is the detachment area of the largest rock avalanche event which occurred in the year 1348. Deep tensional cracks on top of the rock wall on the western flank of “Rote Wand” indicate most likely ongoing slope failure as a result of the aforementioned “hard rock on top of weak rock” situation. The multiple sliding surfaces here are remarkable; all steeply inclined towards the south at around  $50^\circ$  (Fig. 43). The slide planes are very smooth and usually have slickensides structures. On the southwestern part of the “Rote Wand” are rock towers that reach heights of over 100 m.

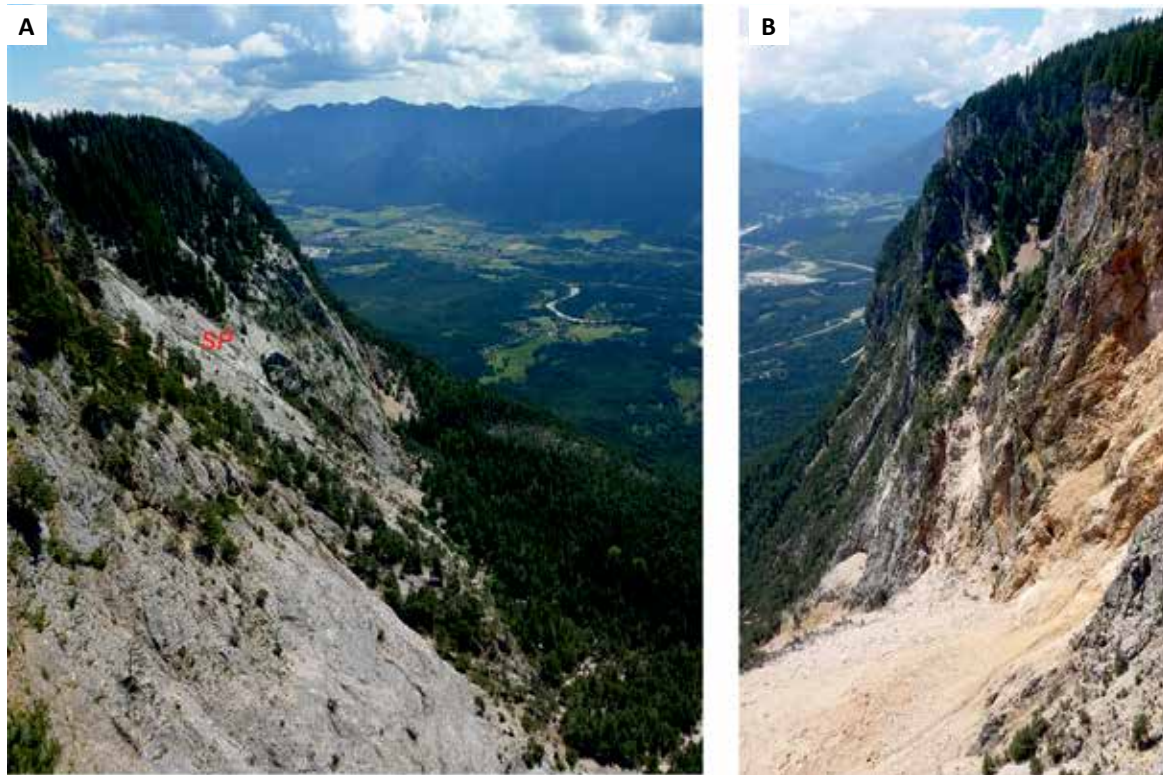
Fig. 43: A- Sliding plane (SP) in the western part of the Rote Wand scarp formed during the event of 1348. B- Eastern part of the Rote Wand scarp with the deposits of recent rock fall deposit.

According to Brandt (1981) rock mass falls larger than 100,000 m<sup>3</sup> and thus a travel angle of below 25- 30° are unlikely. Recent events at the “Rote Wand” scarp (Fig. 43) had a volume of 40,000 m<sup>3</sup> at maximum. Hence, no endangerment of settlements or traffic infrastructure is evident so far. However, open tension cracks along the flanks indicate ongoing loosening of the steep cliff and the preparation of further rock mass fall events.

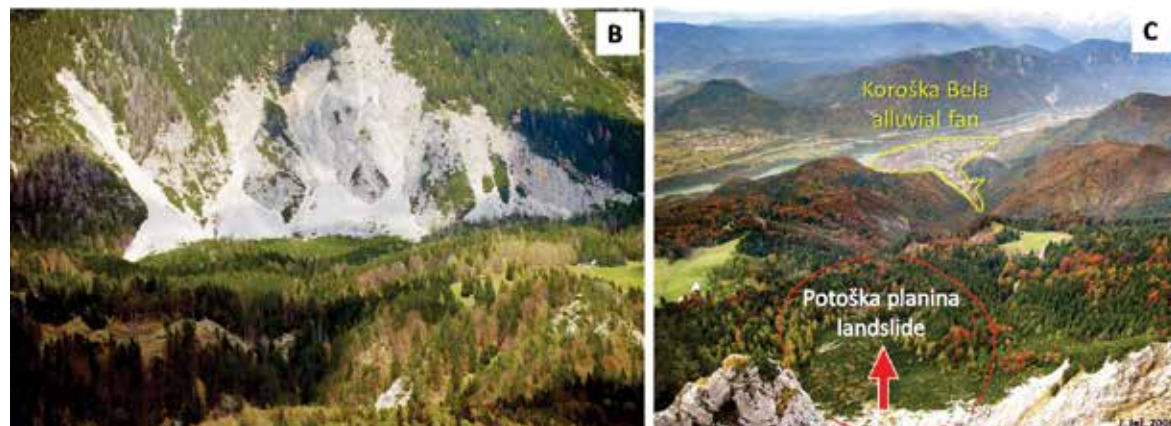
Fig. 44: A- Engineering geological map of watershed of Bela torrent with its hinterland (adopted by Jež et al., 2008). For each engineering unit a type of slope mass movements was defined based on field surveying (Sodnik et al., 2017); B- Panoramic view from Kočna to the Belčica limestone ridge and Potoška planina. C- View from the Belčica limestone ridge, looking directly down to the Potoška planina landslide onto the village of Koroška Bela that lies on the alluvial fan.

The Potoška planina landslide is located in the Karavanke mountain range (NW Slovenia) above the densely populated settlement of Koroška Bela, which has almost 2,200 inhabitants (Fig. 44). Current landslide activity is evidenced by the “pistol butt” trees, scarps, open longitudinal cracks (Fig. 45) and the deformation of local roads. Similarly, historical sources describe a severe debris flow at the end of the 18th century that destroyed nearly 40 houses in the village of Koroška Bela. In total the landslide covers an area of 0.2 km<sup>2</sup> with an estimated maximum volume of sliding mass of roughly 1.8 × 10<sup>6</sup> m<sup>3</sup> (Jež et al., 2008; Komac et al., 2015). In general, the broader area of the Potoška planina area exhibits highly complex geological and tectonic characteristics, which exert an influence on various slope mass movements. The upper part of the landslide consists of carbonate rocks and scree deposits that are largely prone to rock slides (Fig. 44B), while the main body of the landslide consists of heavily deformed Upper Carboniferous and Permian clastic rocks, which are characterized by complex dynamic movement, and is presumed to be a rotational, deep-seated slow-motion slide accelerated by the percolation of surface and groundwater (Jež et al., 2008; Komac et al., 2015, Peternel et al., 2017) (Fig. 44A). Due to the several springs at the contact point between scree and fine grained clastic rocks the landslide area is partially covered by wetlands, and the Bela stream increases the possibility of mobilization of the material into debris flow (Peternel et al., 2017). Based on UAV photogrammetry and tachymetric measurements, Peternel et al. (2017) monitored the toe of the landslide where, during an observation period of nearly two years, the assessed displacements ranged between 0.9 and 17.9 m (Fig. 46). As a prevention measure, a recording system that provides real-time monitoring of landslide behavior was installed as part of the European project Recall, which can play a role in the process of establishing an EWS in the future (Jemec Auflič et al., 2017).

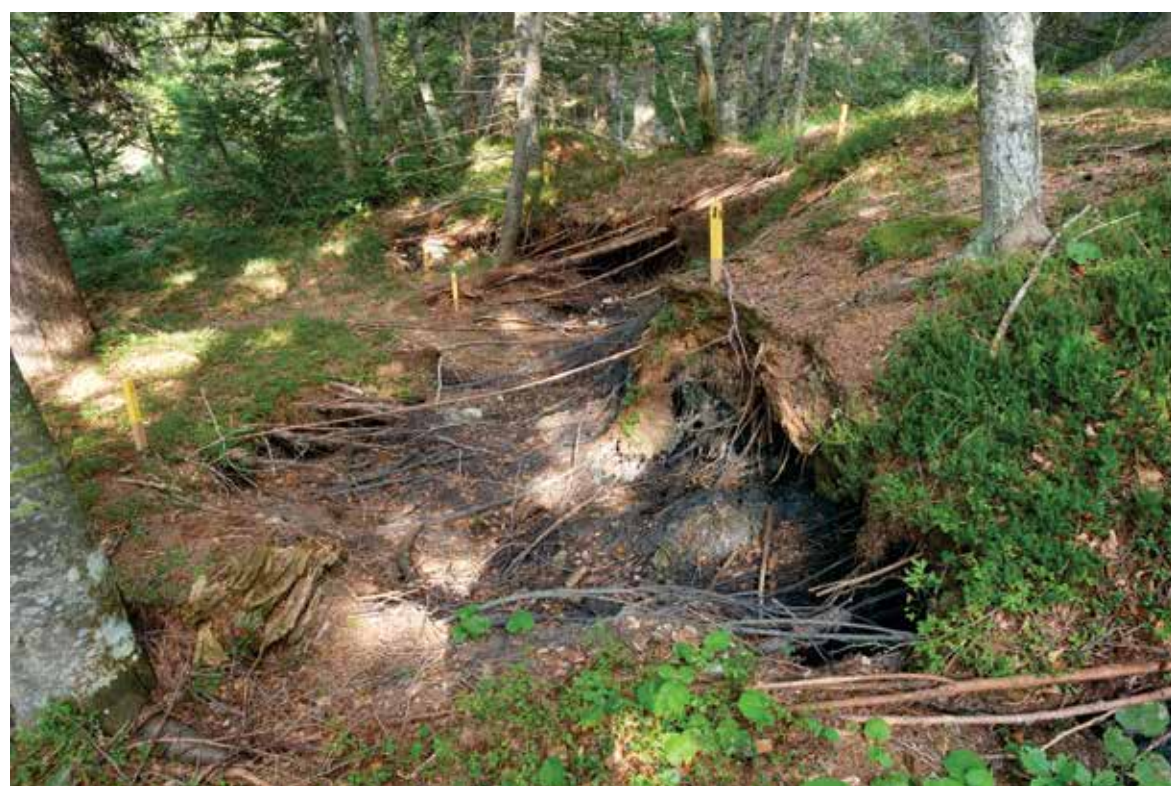
Fig. 45: Longitudinal cracks and stretching of tree roots in the Carboniferous and clastic rocks.

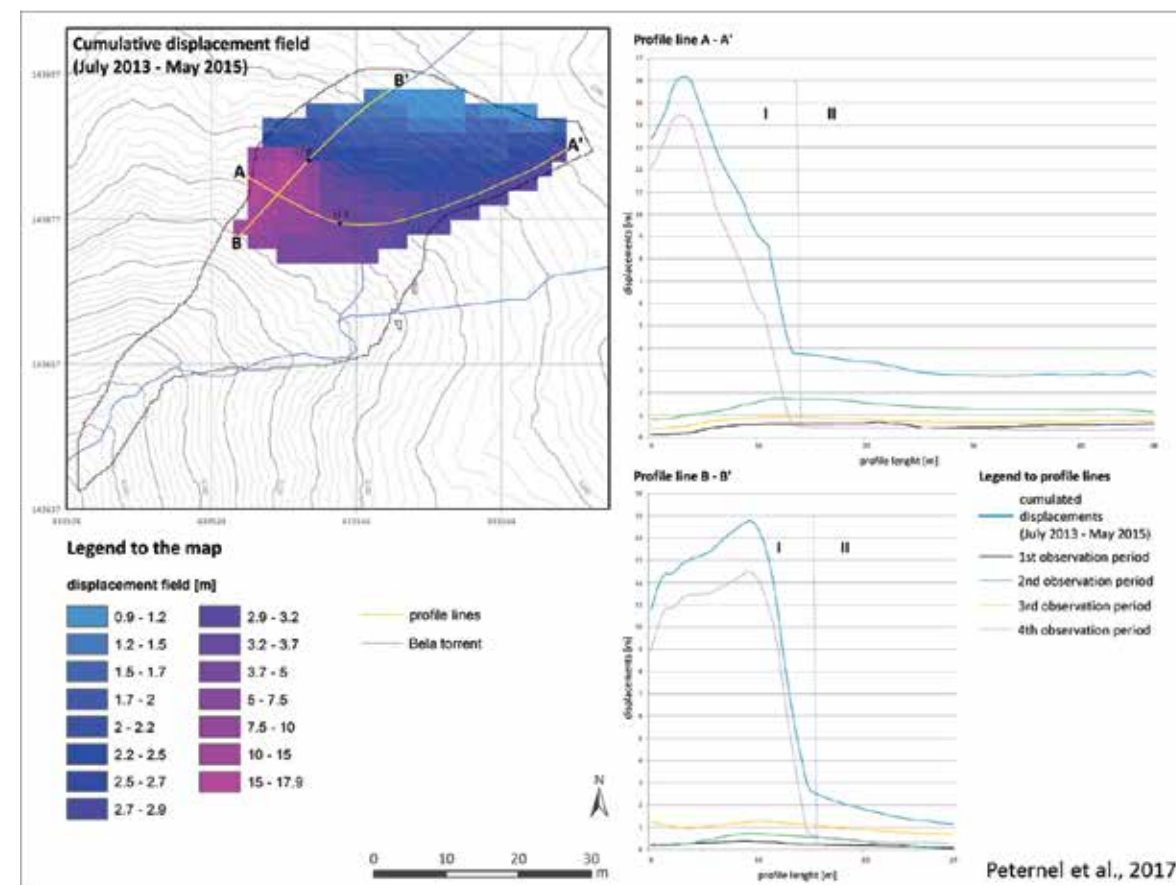
Fig. 46: Cumulative displacement field obtained with UAV photogrammetry and characteristics profiles that represent behavior of the lower part of Potoška planina landslide (Peternel et al., 2017).

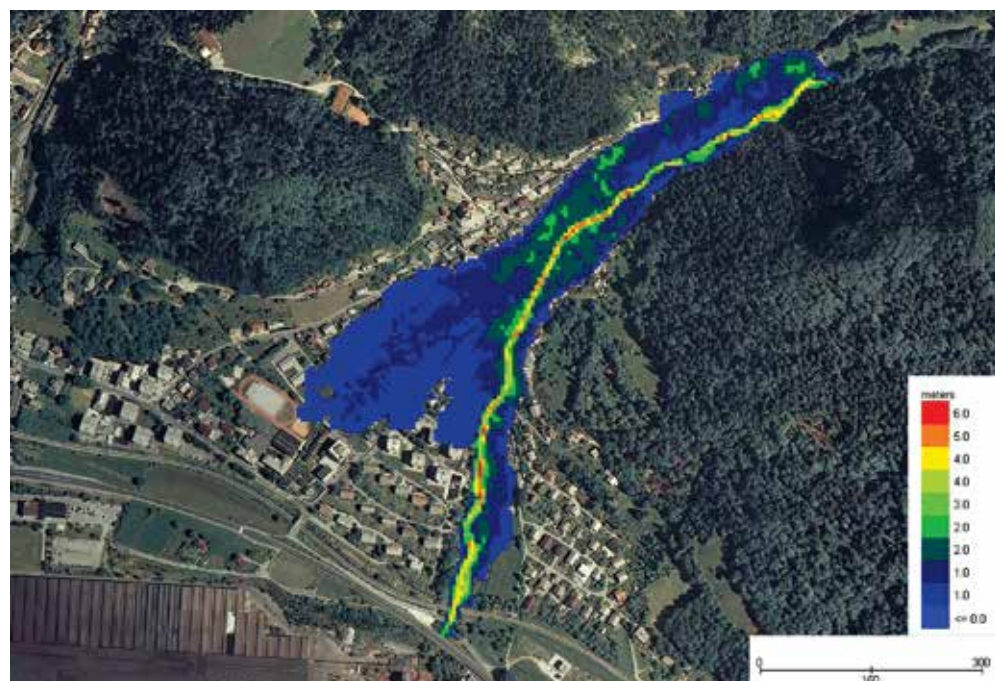
Fig. 48: Maximum flow depths of potential debris flow on Koroška Bela fan (Sodnik et al., 2012).

In the final phase of debris flow hazard assessment (hazard mapping), mathematical modeling of debris flow on torrential fan is crucial for reliable debris flow hazard maps. Topographical data are very important input data and have significant impact on the results (Sodnik et al., 2017). Different sets of data were used and results were compared in terms of results (maximum flow depths, maximum flow velocities and computational times) to determine optimal set of topographic data for mathematical modeling in process of debris flow hazard assessment (Fig. 48).
